HAWAII DEEP WATER CABLE PROGRAM  
BOTTOM ROUGHNESS SURVEY OF THE  
ALENUIHAHA CHANNEL

HAWAIIAN DREDGING & CONSTRUCTION CO.

MAKAI OCEAN ENGINEERING, INC.  
ED NODA & ASSOCIATES  
HAWAII INSTITUTE OF GEOPHYSICS

May 1, 1986

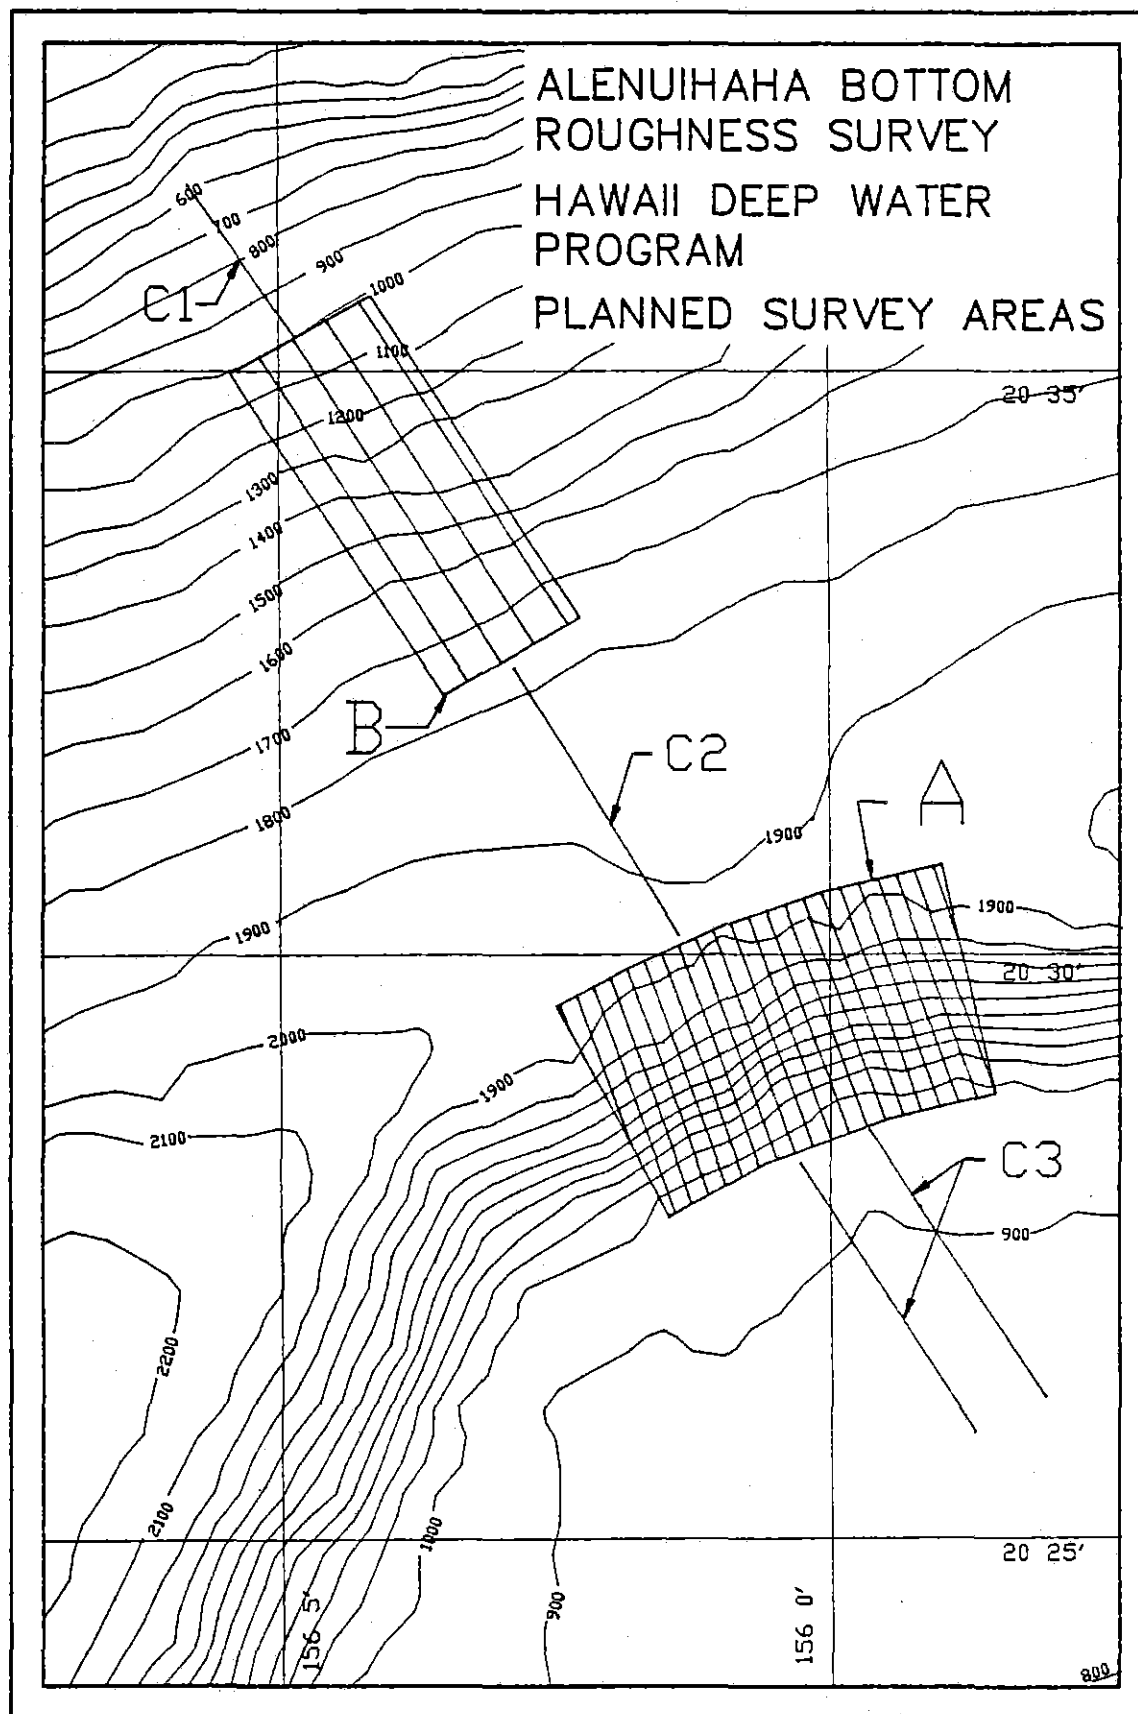
FIGURE 2: Specific survey sites in the Alenuihaha  
Channel: Cruise #1

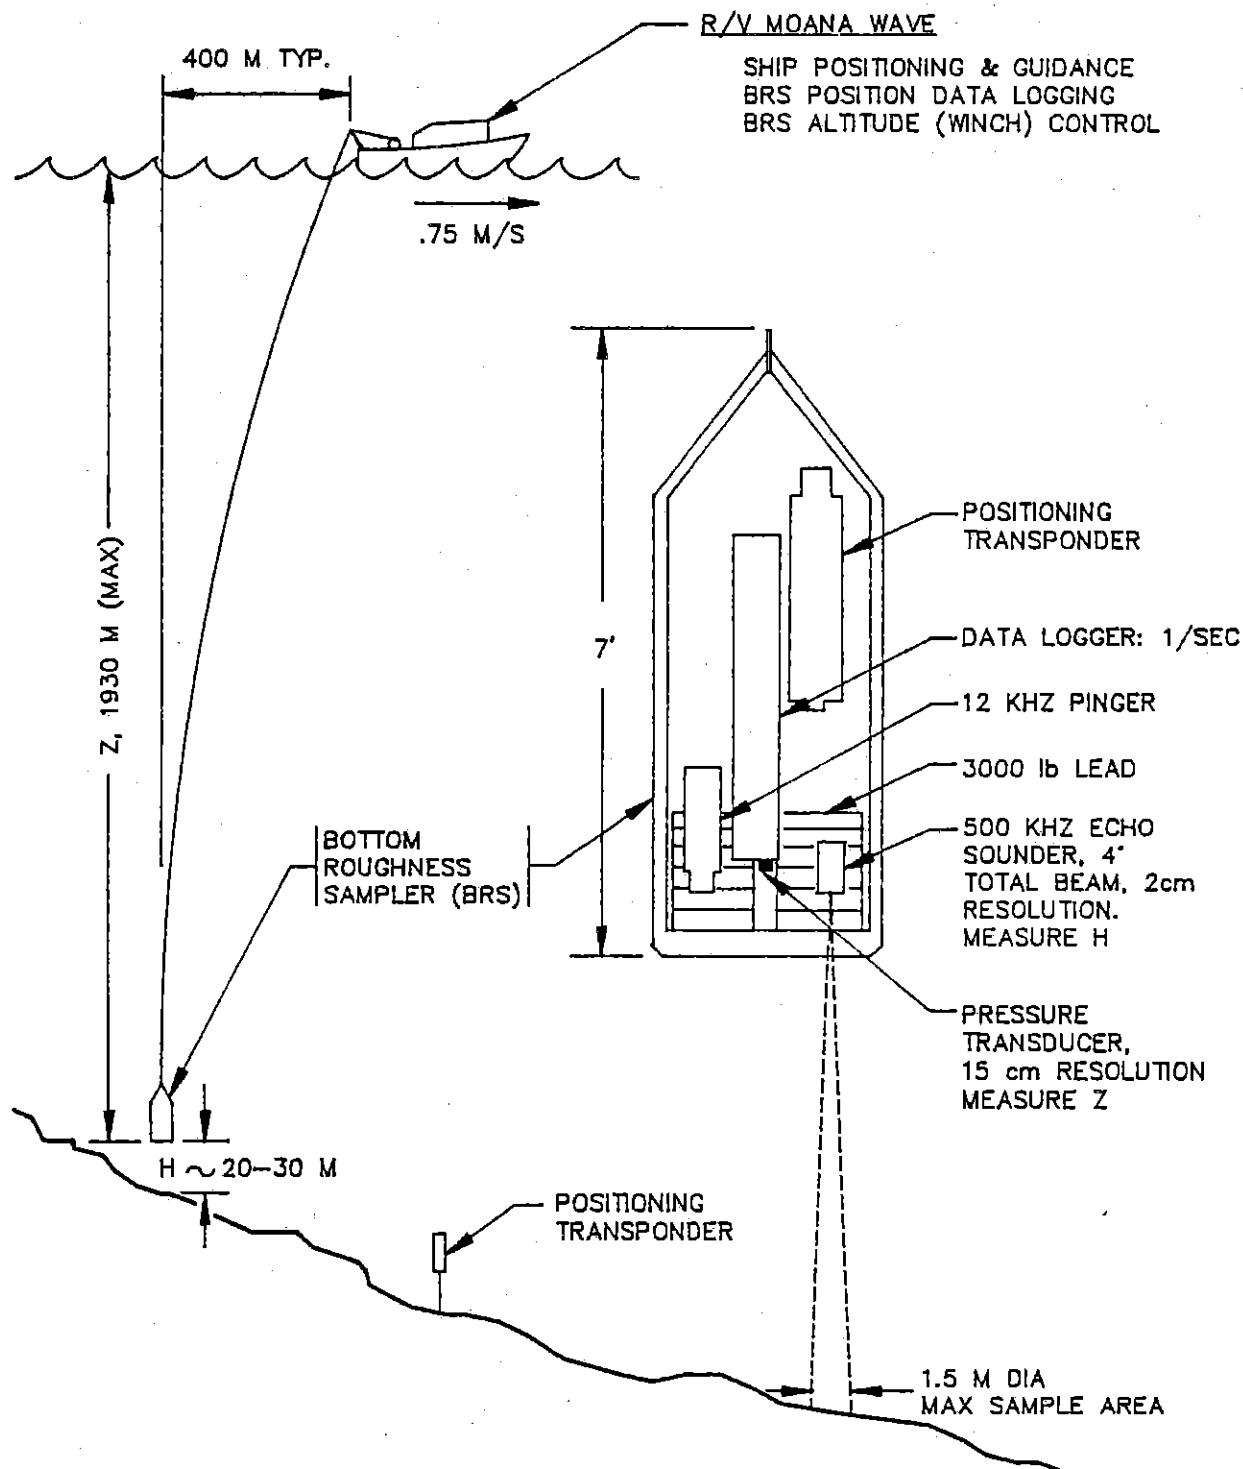
FIGURE 5

The Ulvertech Model 205 Echo Sounder was selected as the bottom roughness profiler, which operates at about 500 kHz with a 4 degree beam angle at 3dB points. The Model 205 Echo Sounder has a nominal range of 100 m with a resolution and accuracy of  $\pm 2$  cm (0.8 inch). The echo sounder is nominally rated for a water depth of 1,500 m, and since our depth requirements were greater, a new pressure housing was manufactured by HIG, University of Hawaii.

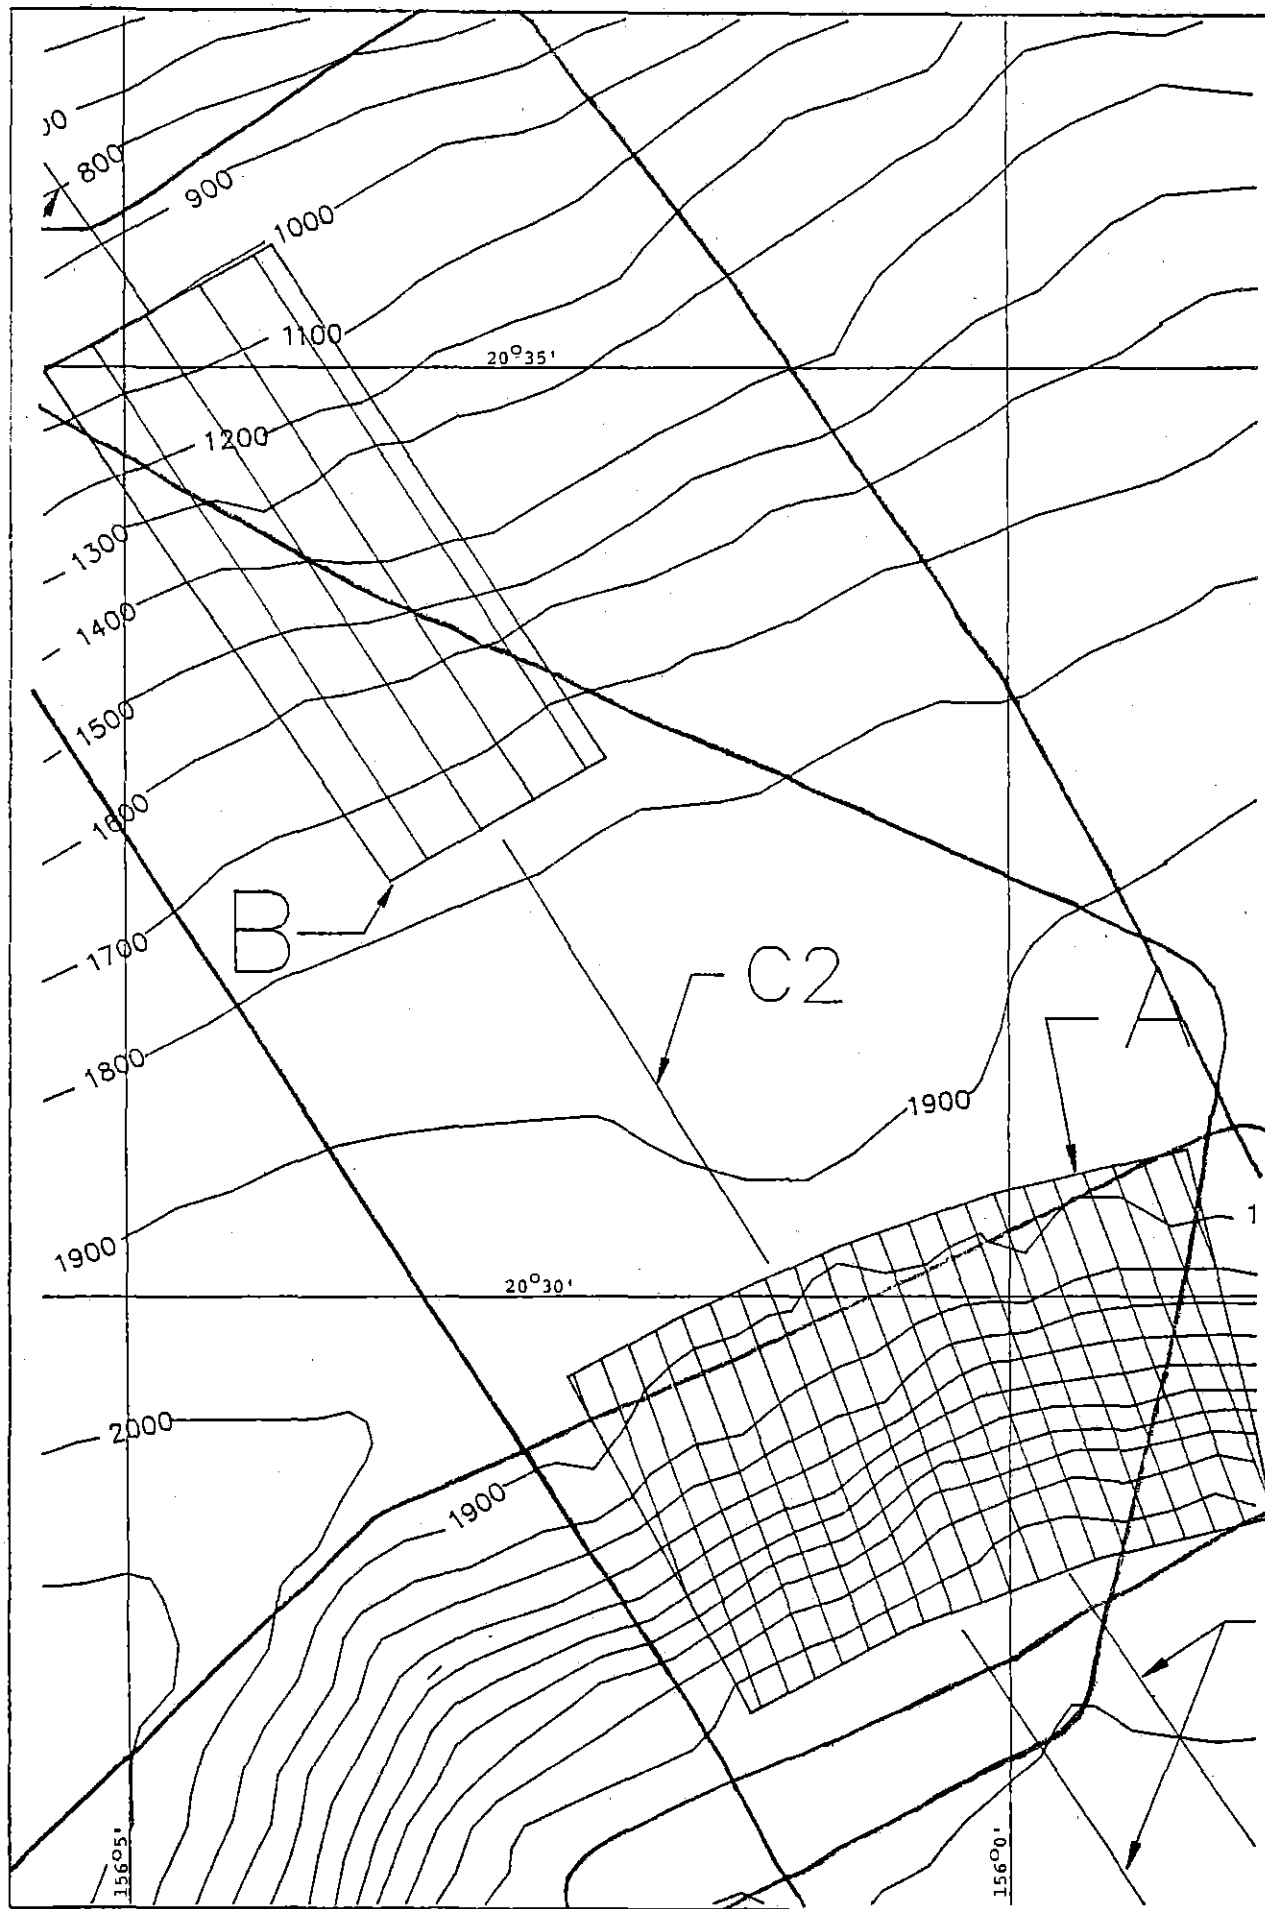
Figure 6: Tow paths followed by SeaMARC side scan system to obtain overlapping and varying views of the survey area

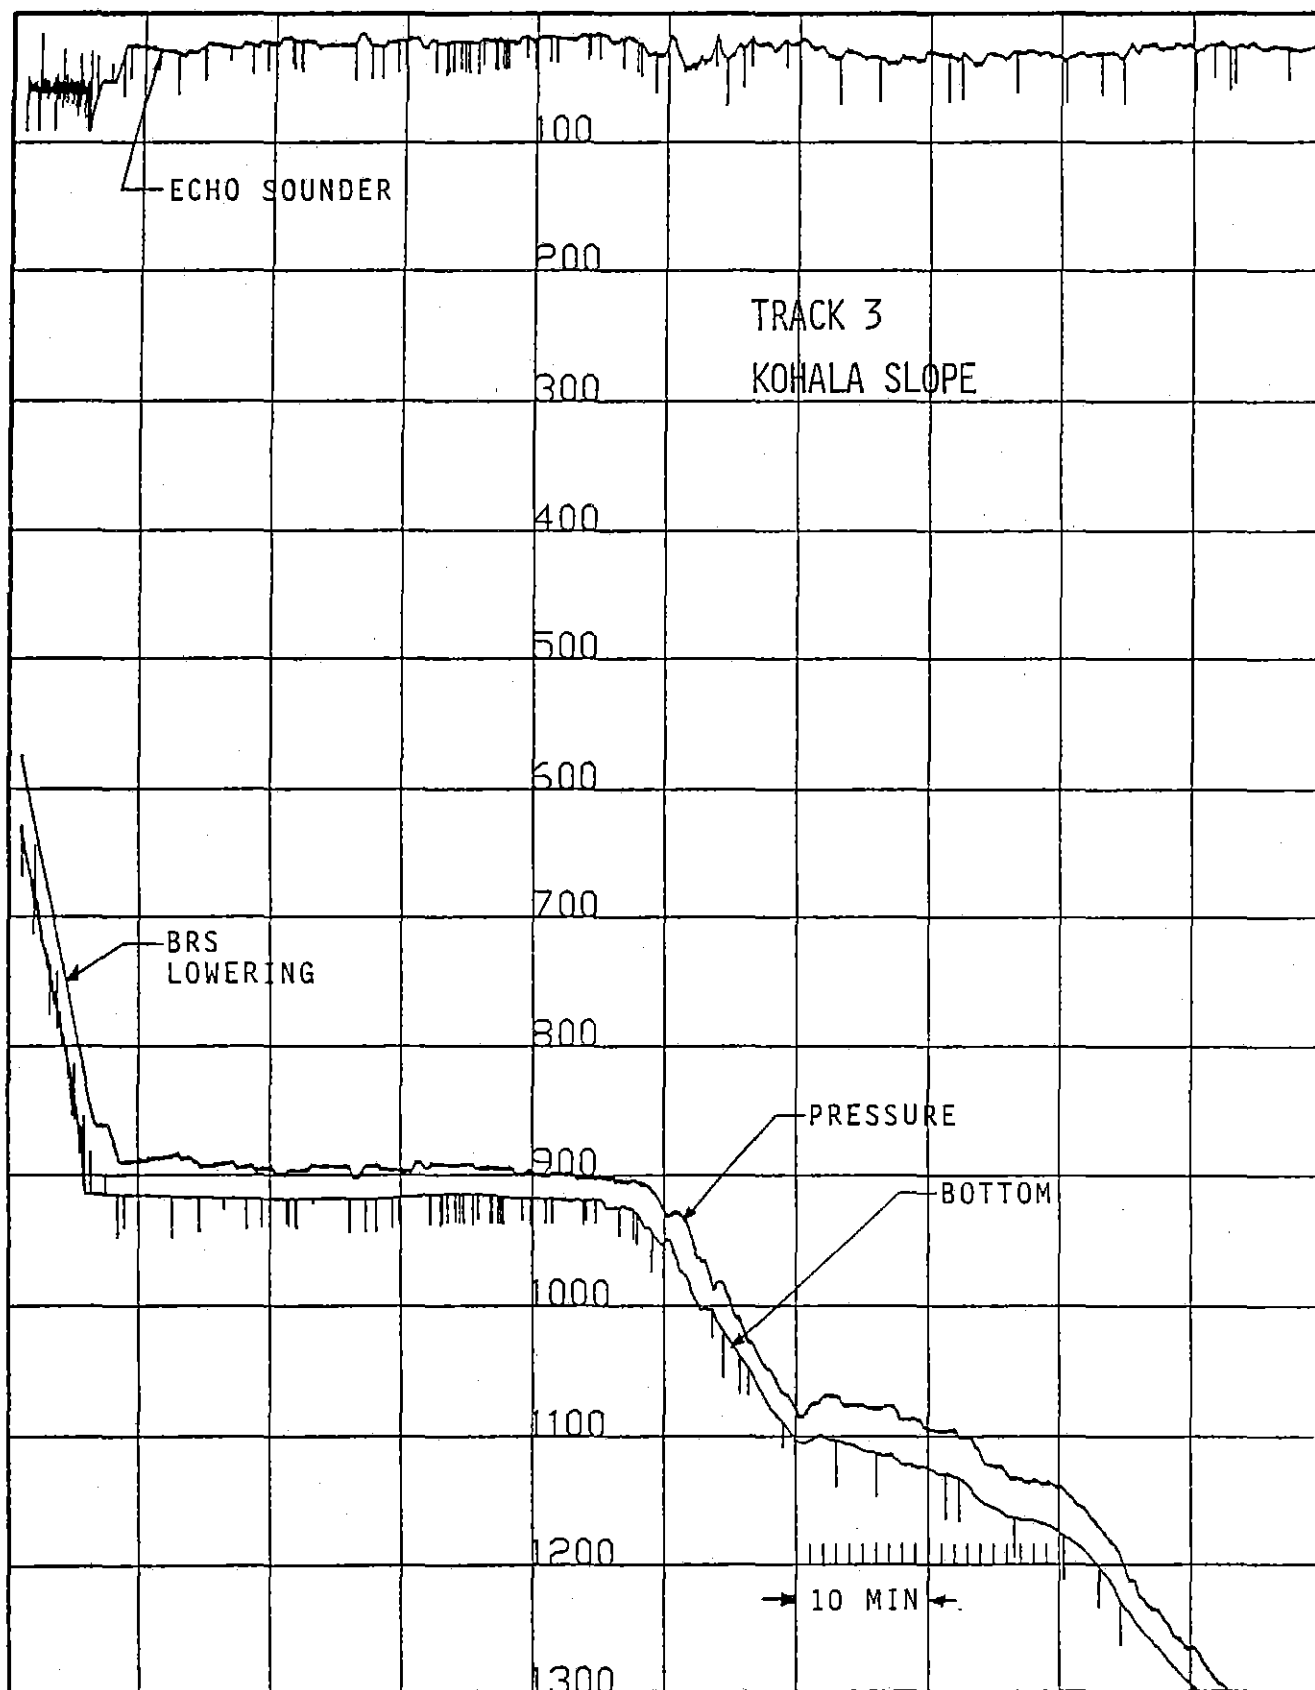
FIGURE 7: Typical BRS data showing the pressure, altitude, and bottom data.

The detail contained in the bottom roughness data cannot be readily seen in Figure 7. Over 15,000 data points are used to generate this illustration. An expanded track is illustrated in Figures 8 and 9. Here some of the detail is apparent in both the pressure and the echo sounder data. The BRS shows strong vertical movement because of the heave of the MOANA WAVE but this motion is completely taken out through the echo sounder data and, in some cases, the bottom is seen to be perfectly smooth. This was the primary method of checking the accuracy and timing of the pressure transducer and echo sounder signals. When the two independent and widely varying signals can be added to produce a smooth bottom the BRS is performing well.

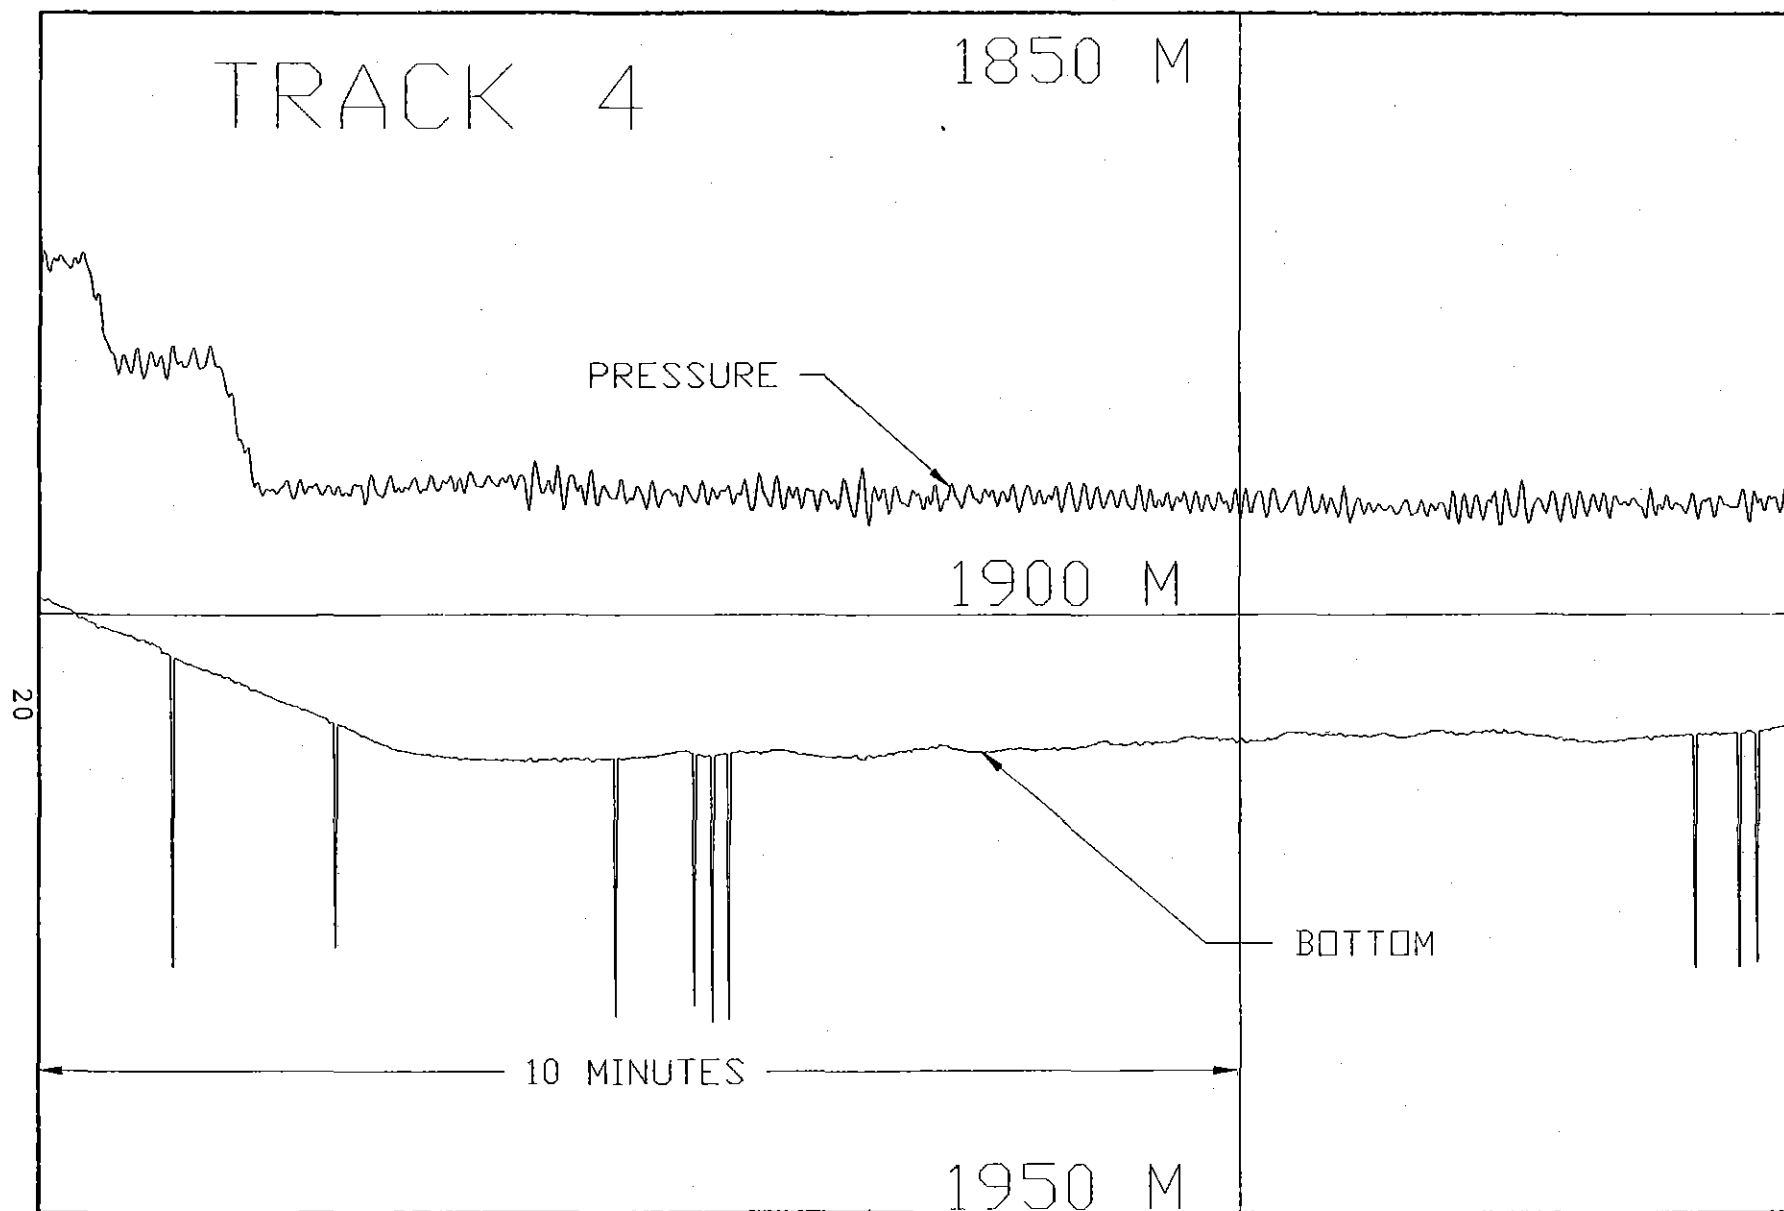
FIGURE 8: Track 4 at the base of the Kohala Slope illustrating the BRS movement due to vessel heave and the relatively smooth bottom. Spikes in the bottom are caused by unreturned echos in the profiler.

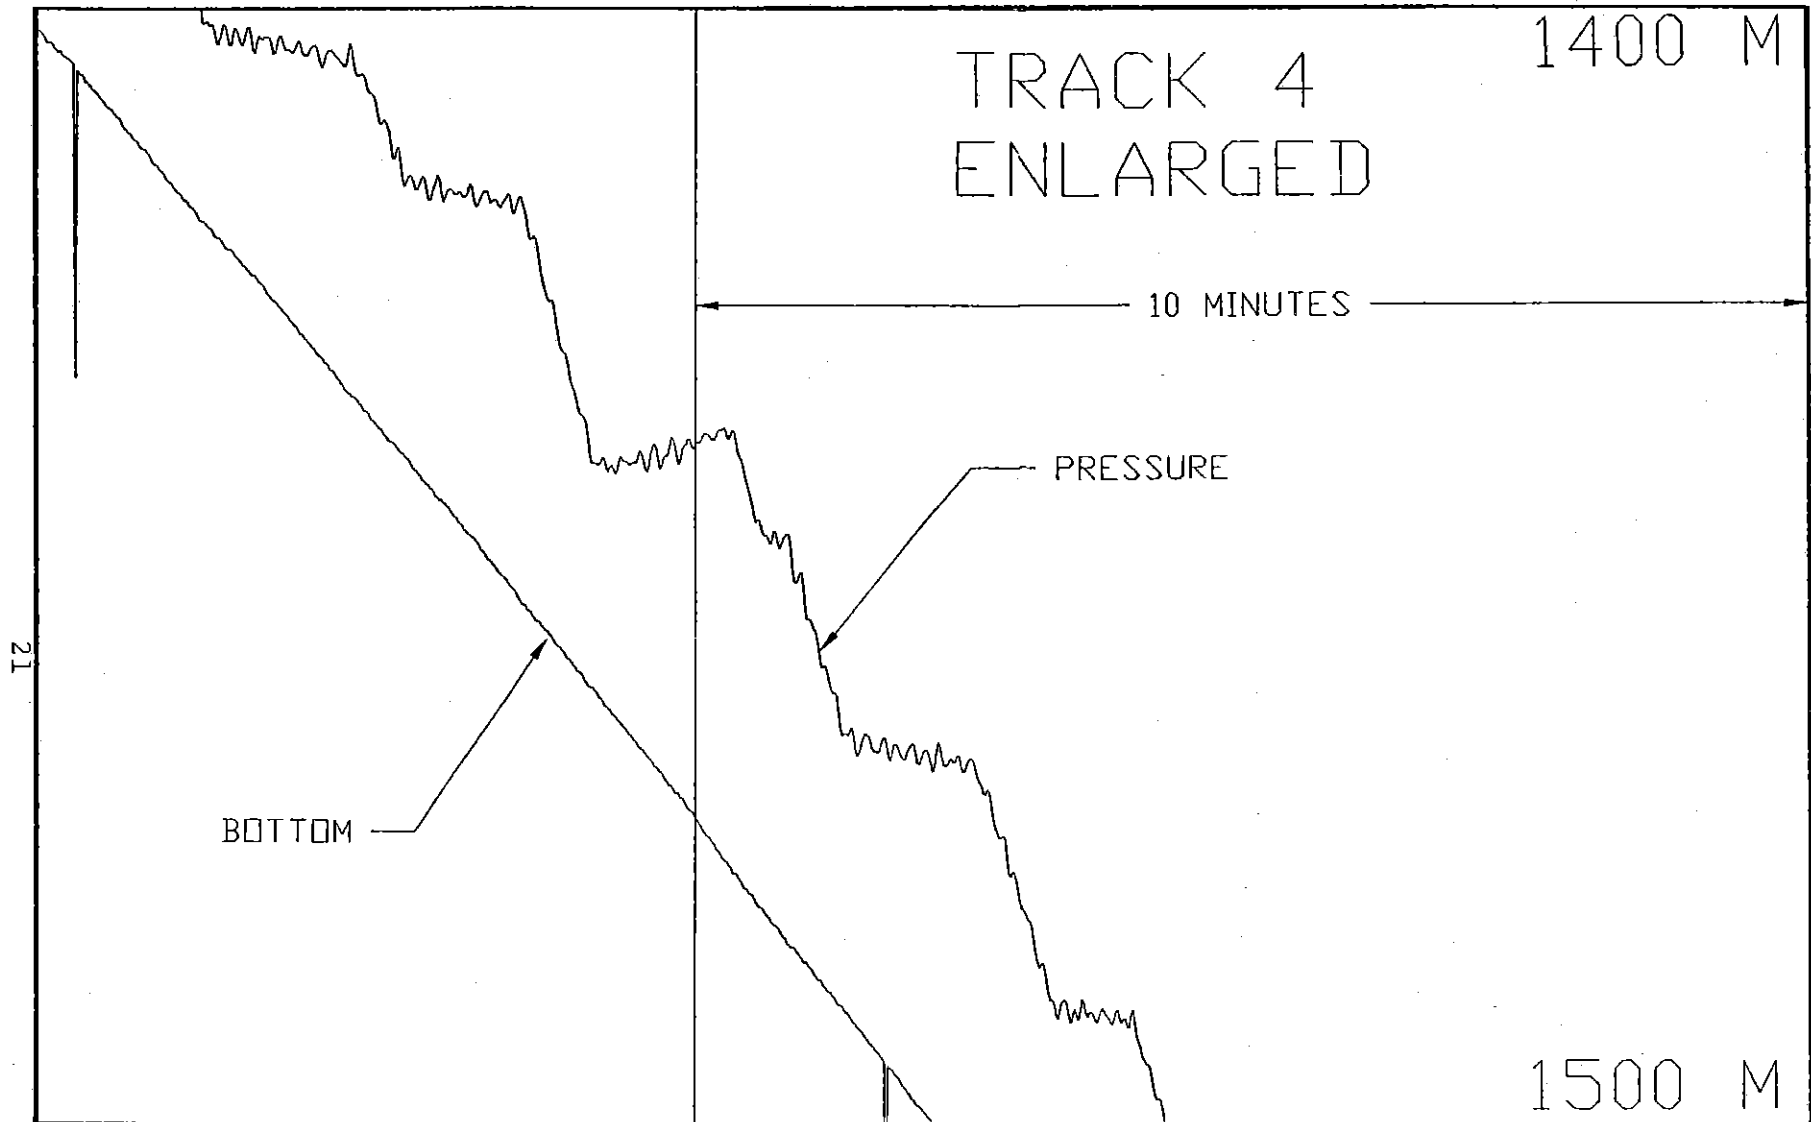
FIGURE 9: Track 4 along Kohala Slope between 1400 and 1500 m.  
Note the step lowering of the BRS and the very smooth bottom.

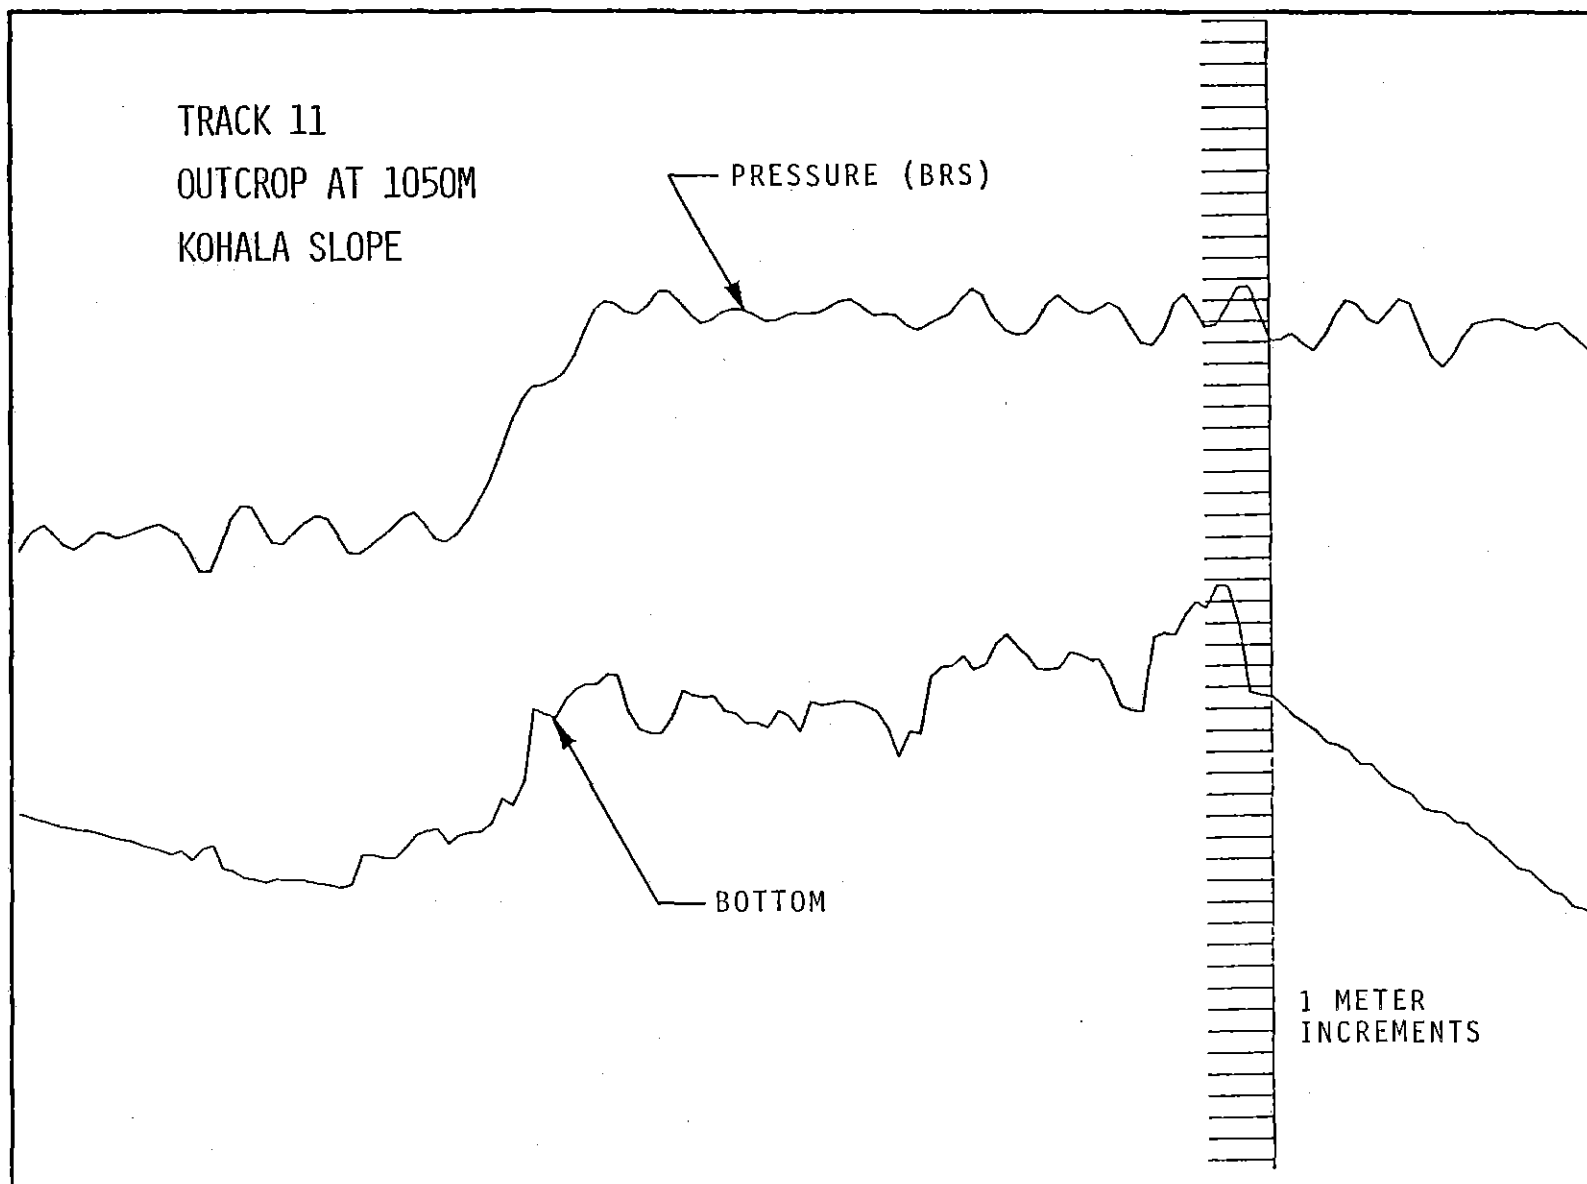
FIGURE 10: Outcrop on Kohala Slope at 1100 m. Note individual data points.  
The horizontal scale equals the vertical scale.

Figure 10 represents further detail on the bottom roughness where each individual data point can be observed. This data is along the Kohala Slope and represents a major rock outcrop.

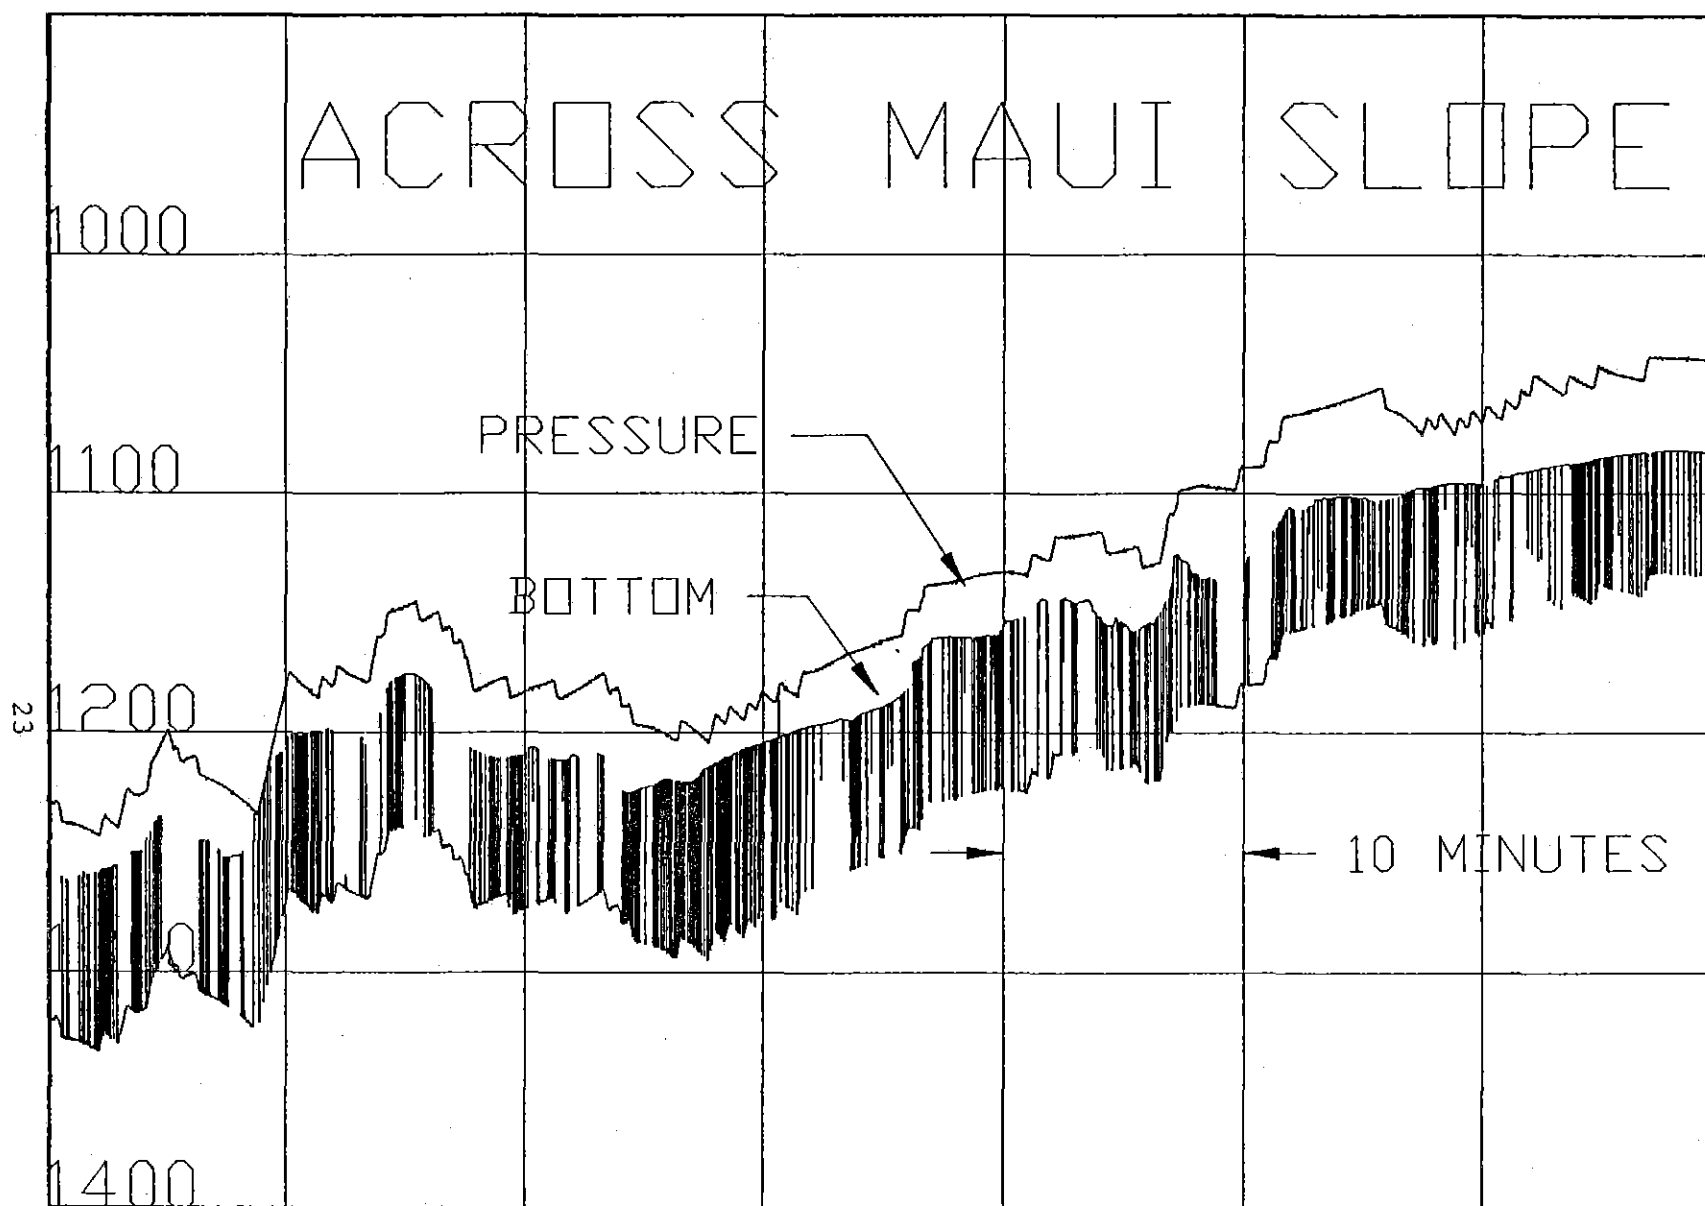
Figure 11: BRS data with an intermittent echo sounder. Bottom profile data is still obtained in spite of a significant loss of data points.

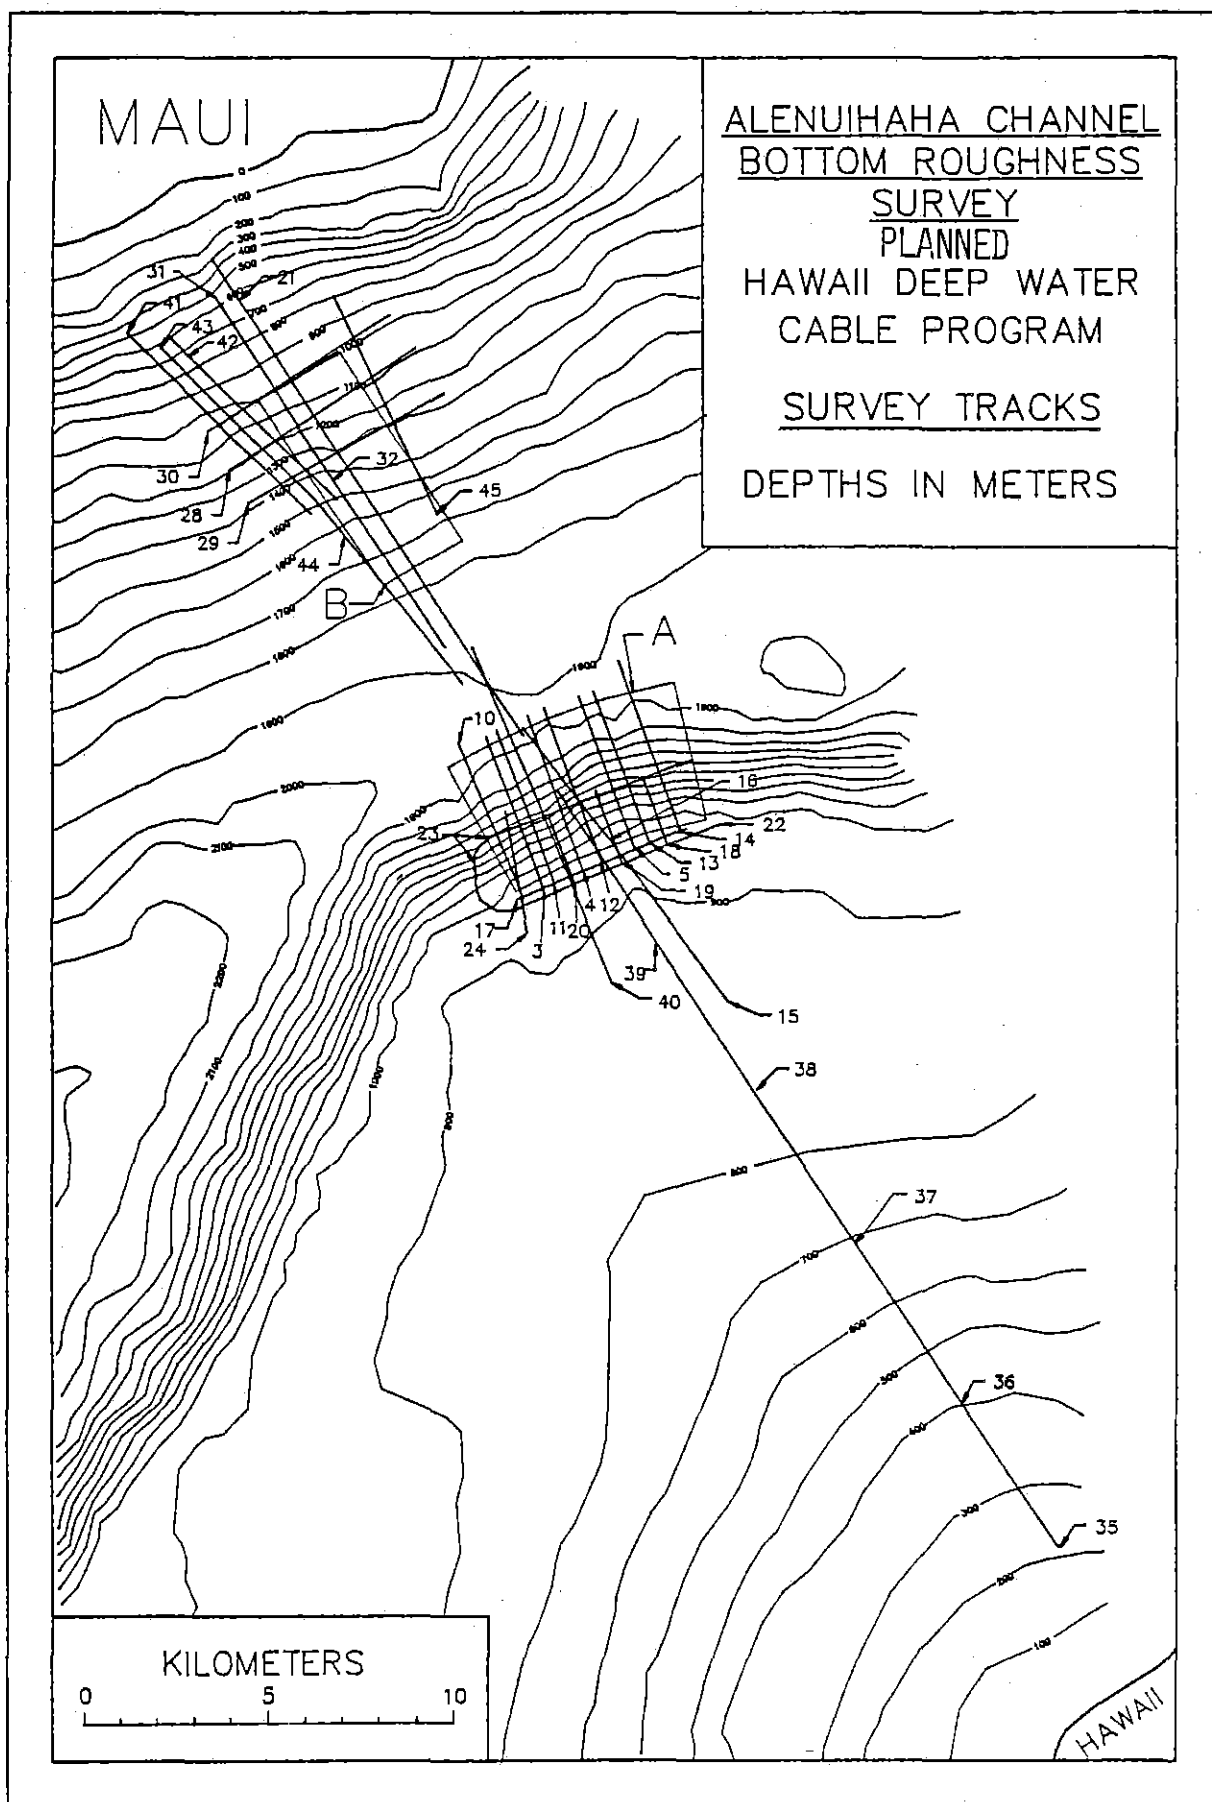
Figure 14.

Figure 15 lists all 45 tracks conducted during this survey. A total of 211 kilometers were surveyed. Thirty km of this data did not provide good roughness data, either because of a short in the echo sounder (Tracks 1 and 2) or a short in the data logger batteries (Tracks 6, 7, 8, 9). The total success rate was 86% with a total of 181 km of good bottom data.

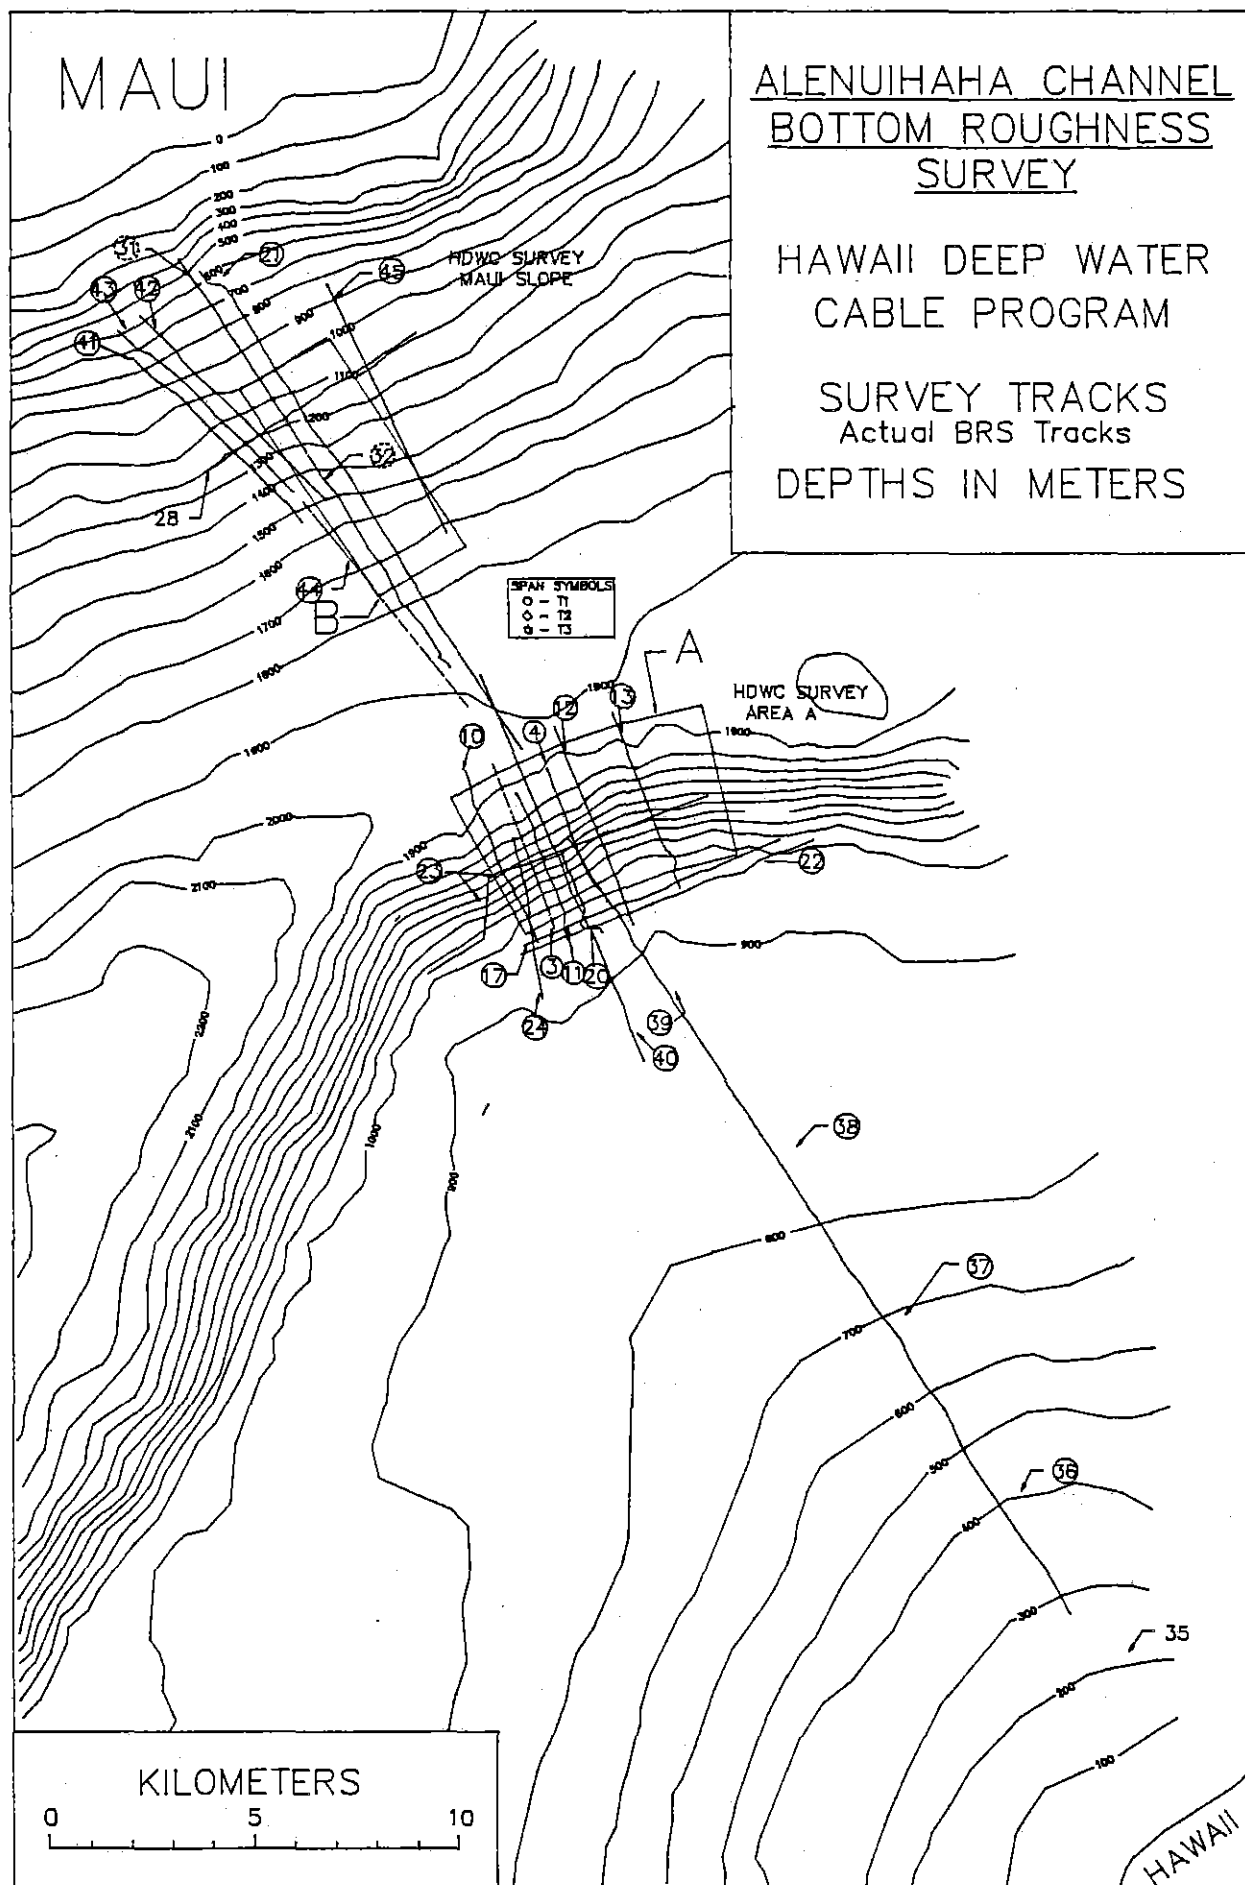
Figure 16 is a plan view of the actual BRS tracks for which the navigation data was adequate and which, upon reviewing the raw data, looked promising as cable routes. Note that the cross Maui tracks and the east Kohala tracks were not processed because they are least likely cable path candidates. These tracks include the correction to estimated BRS position as previously discussed.
